# Situation Photo Log

Thursday, March 29, 2012

Kalamazoo River / Enbridge Spill

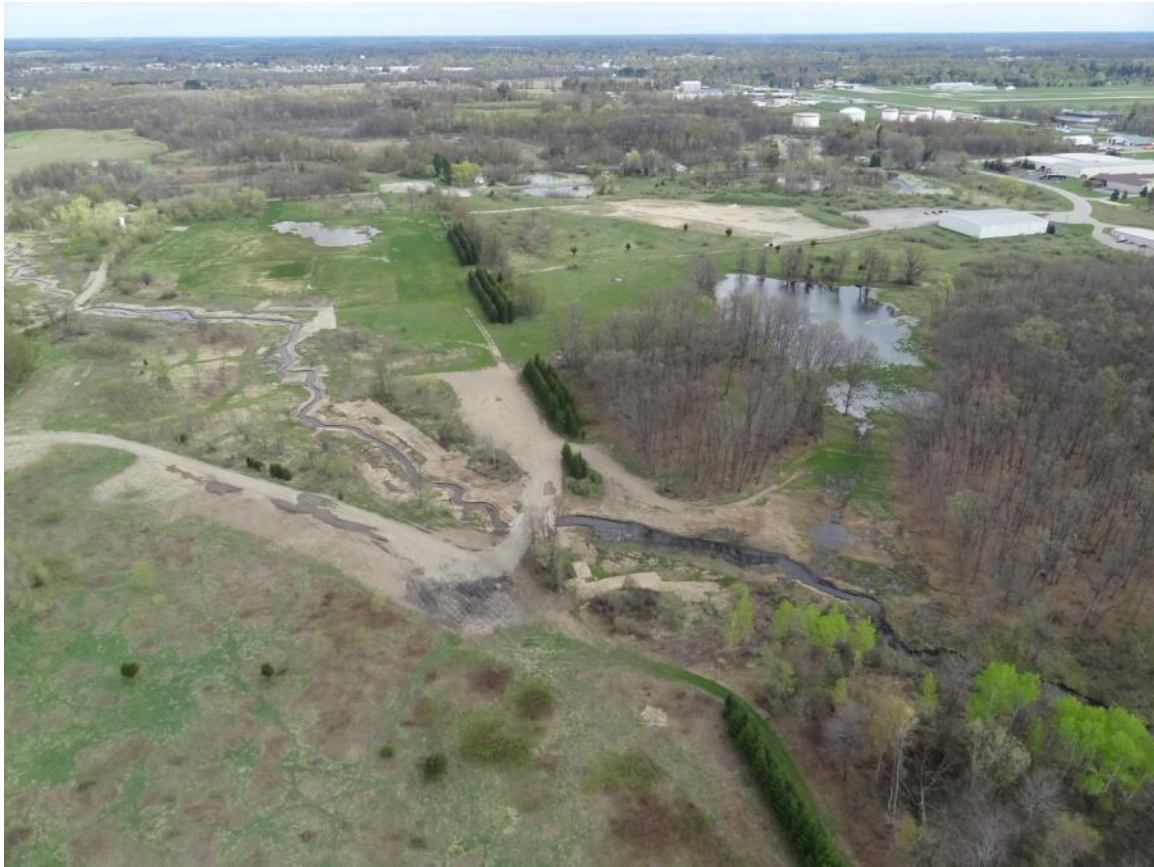
1. Overview of the source area and first half mile of Talmadge Creek.

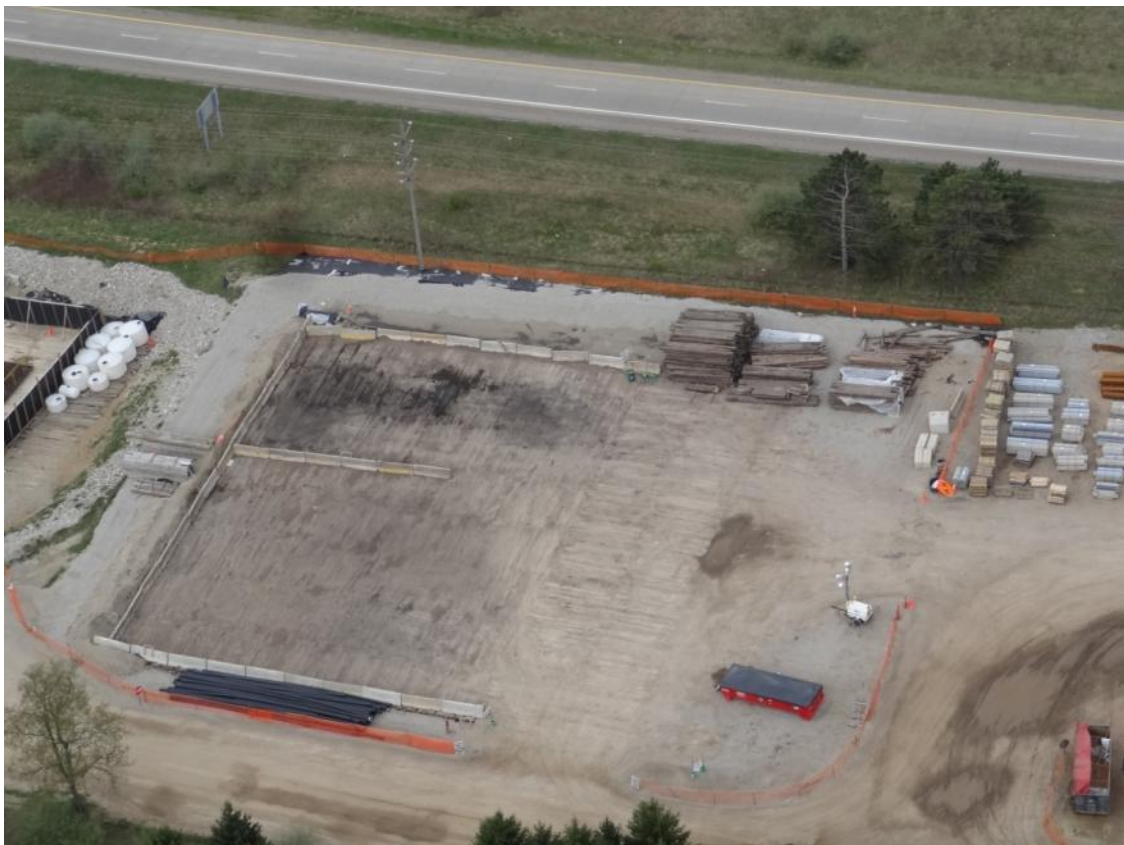
2. Frac-City Soil Cells A & B empty.

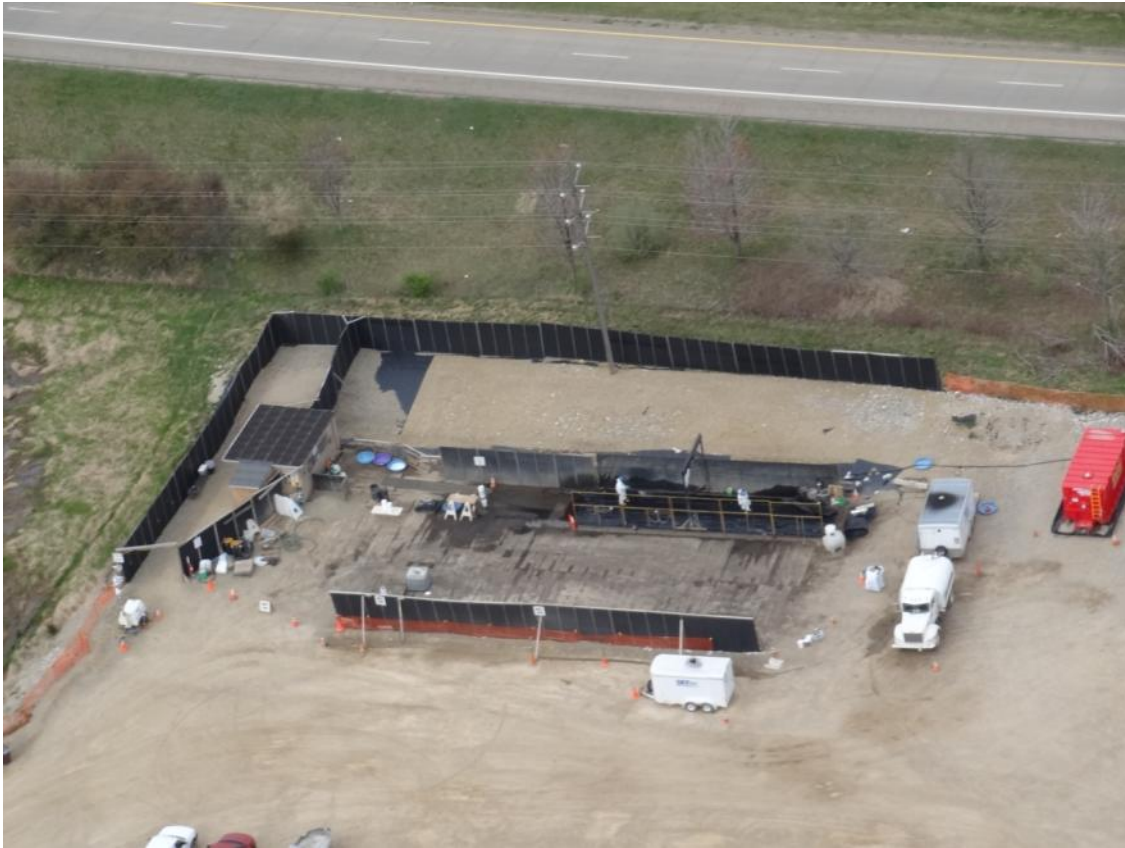
3. Frac-City decontamination activities observed.

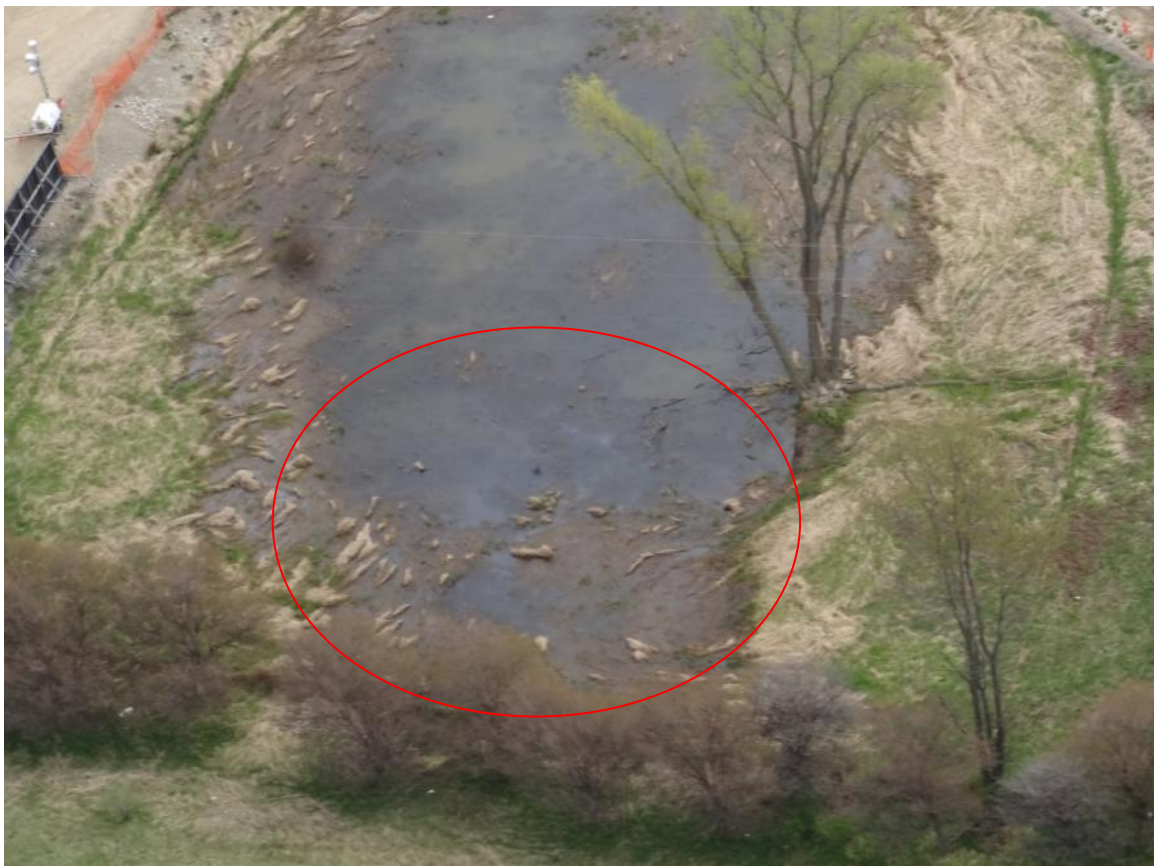
4. Frac-City sheen observed in pond south of decontamination pad.

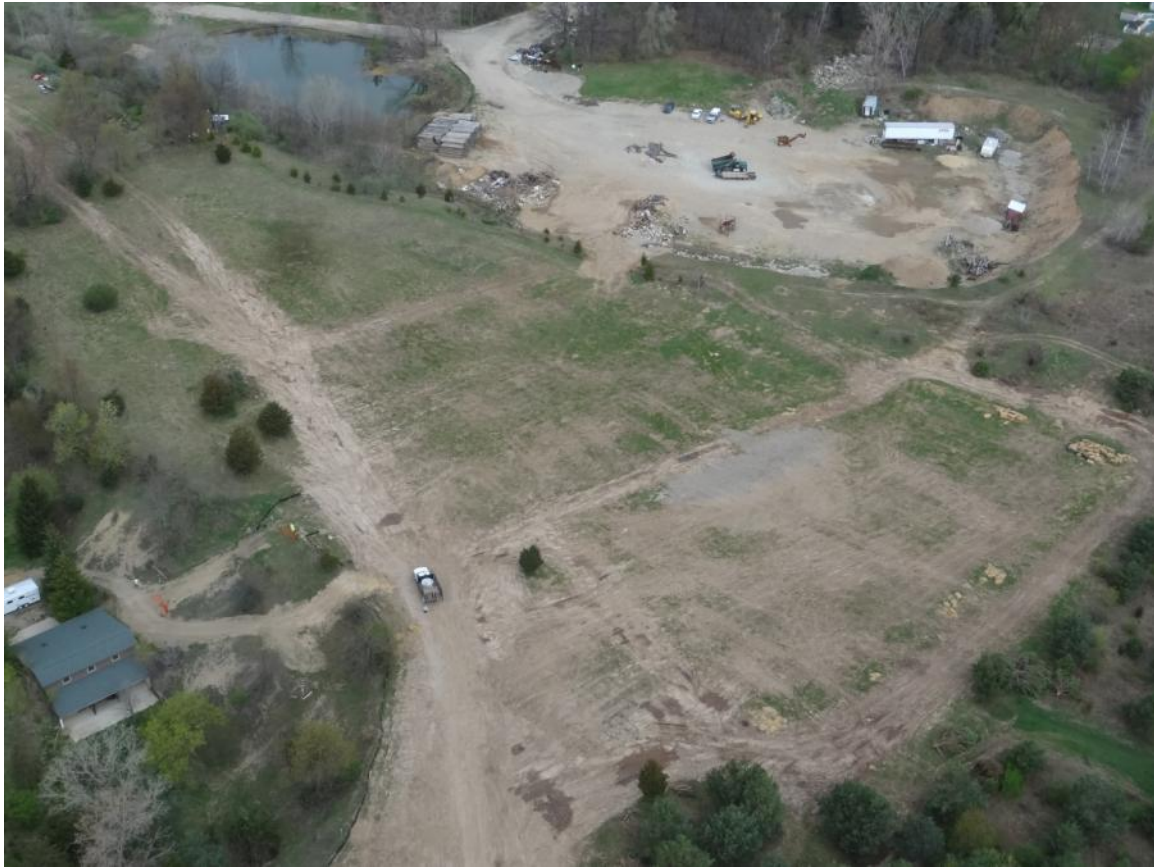
5. Observed crews reducing the foot print around the former location of the turbidity control structure.

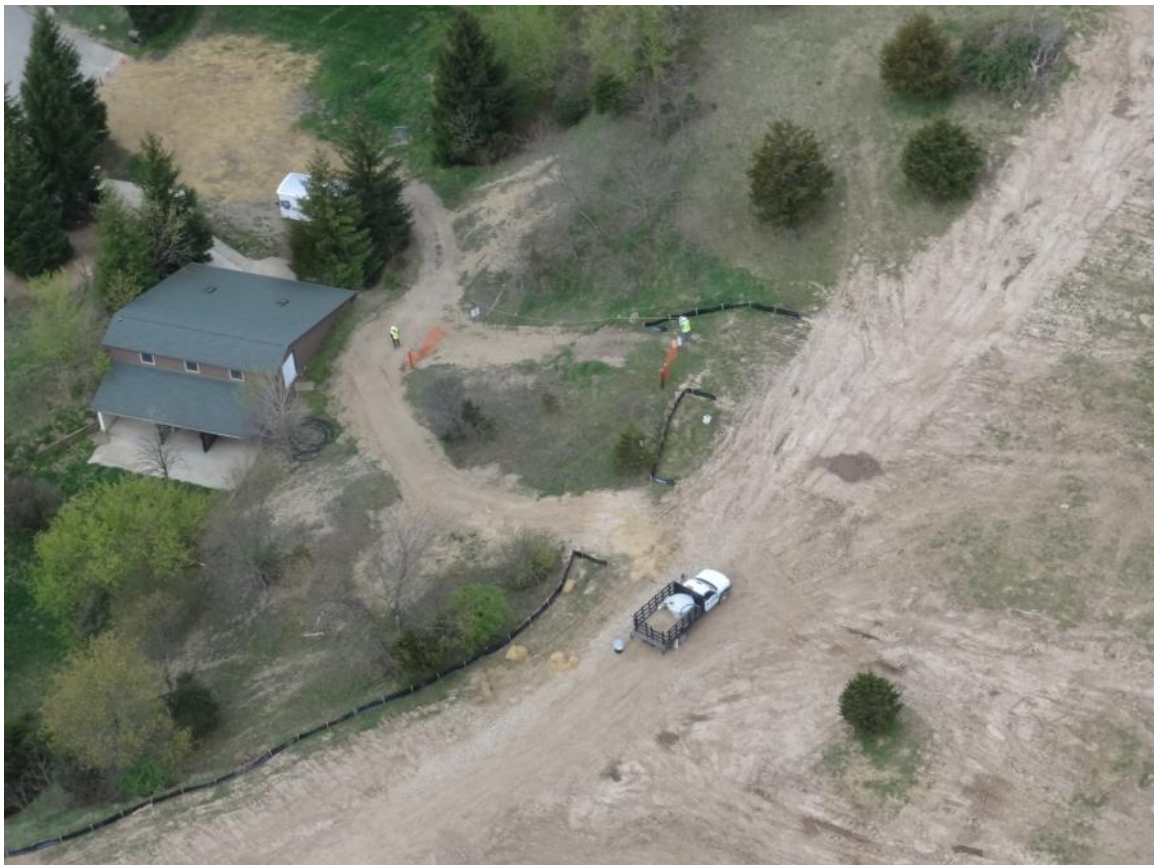
6. Observed crews reducing the foot print around the former location of the turbidity control structure.

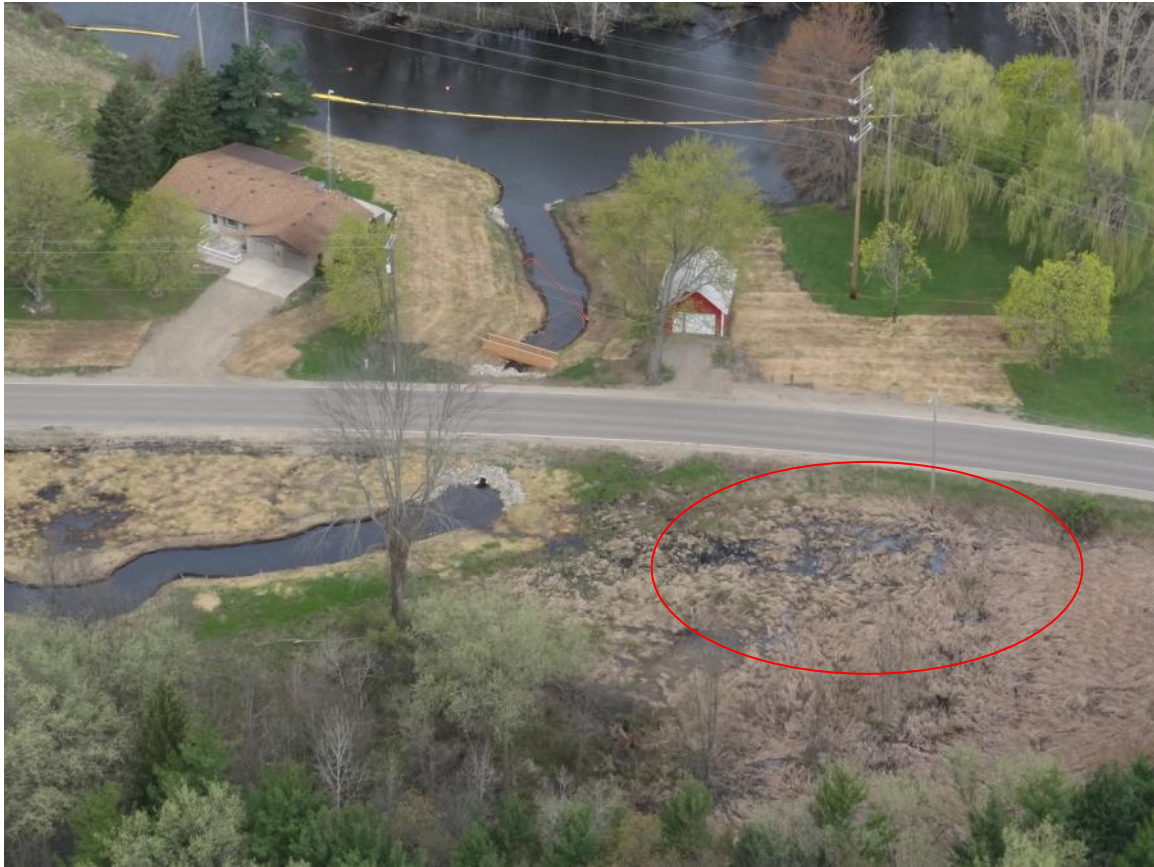
7. Talmadge Creek at A Drive sheen observed.

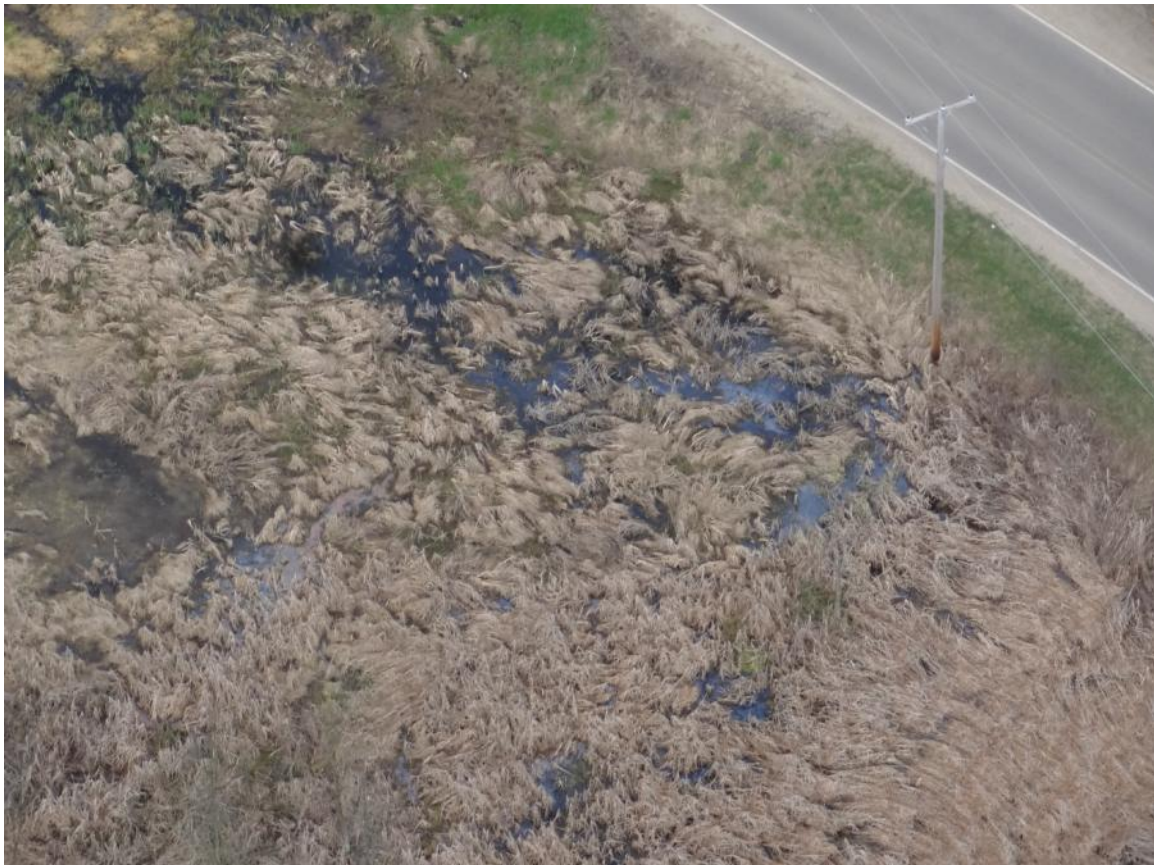
8. Talmadge Creek at A Drive sheen observed.

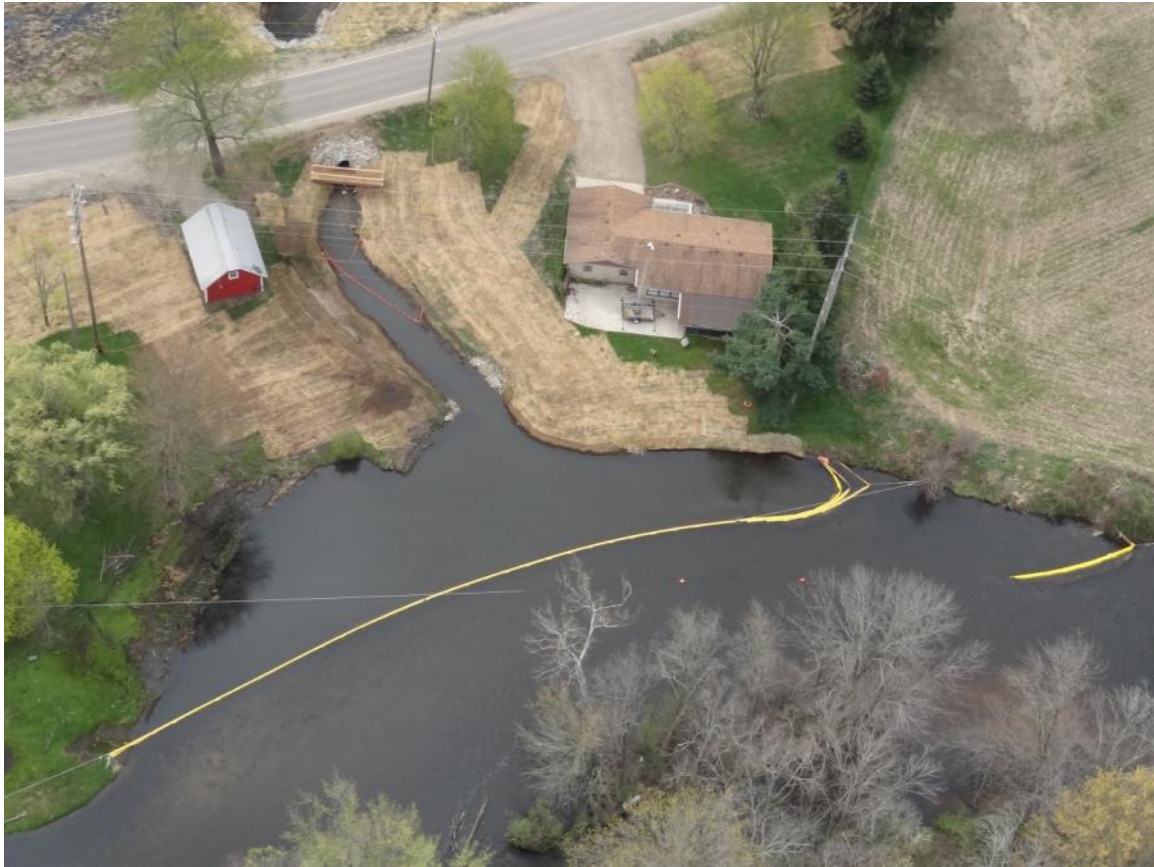
9. Confluence, no turbidity or sheen observed.

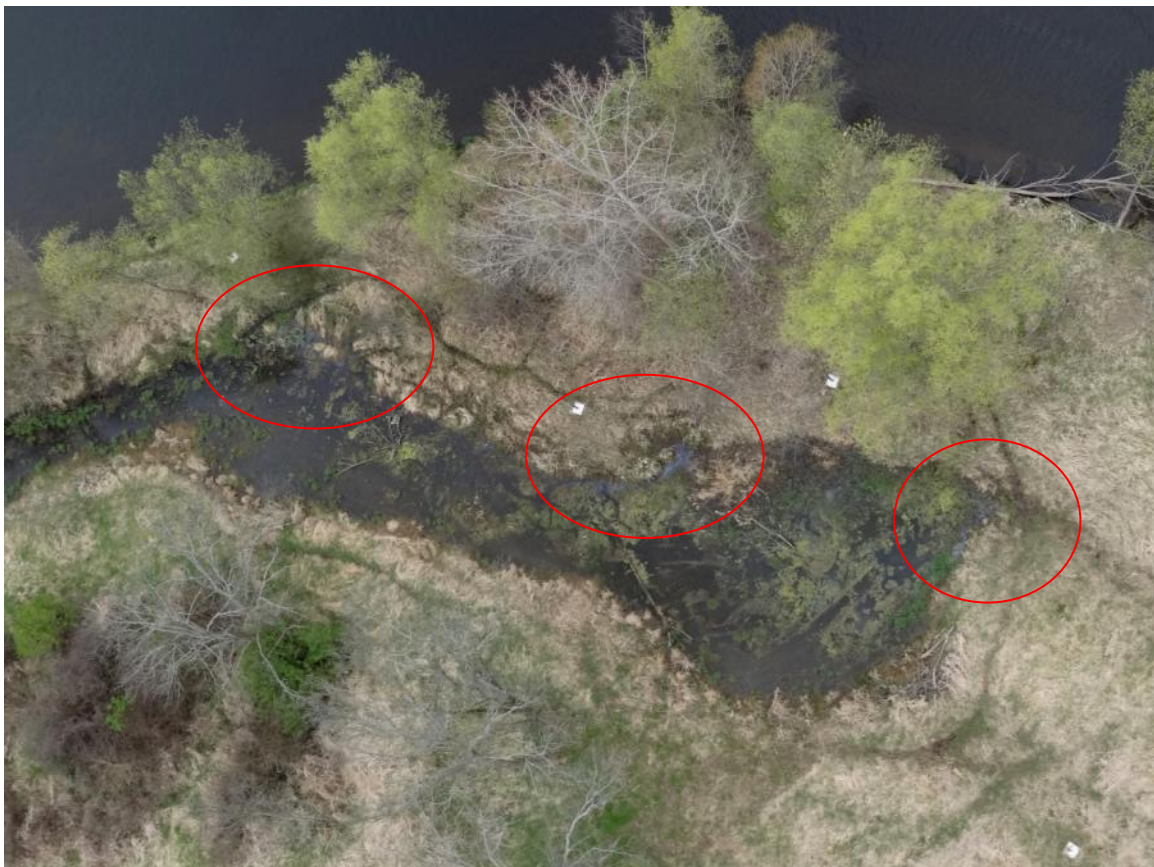
10. MP2.5 LDB sheen observed.

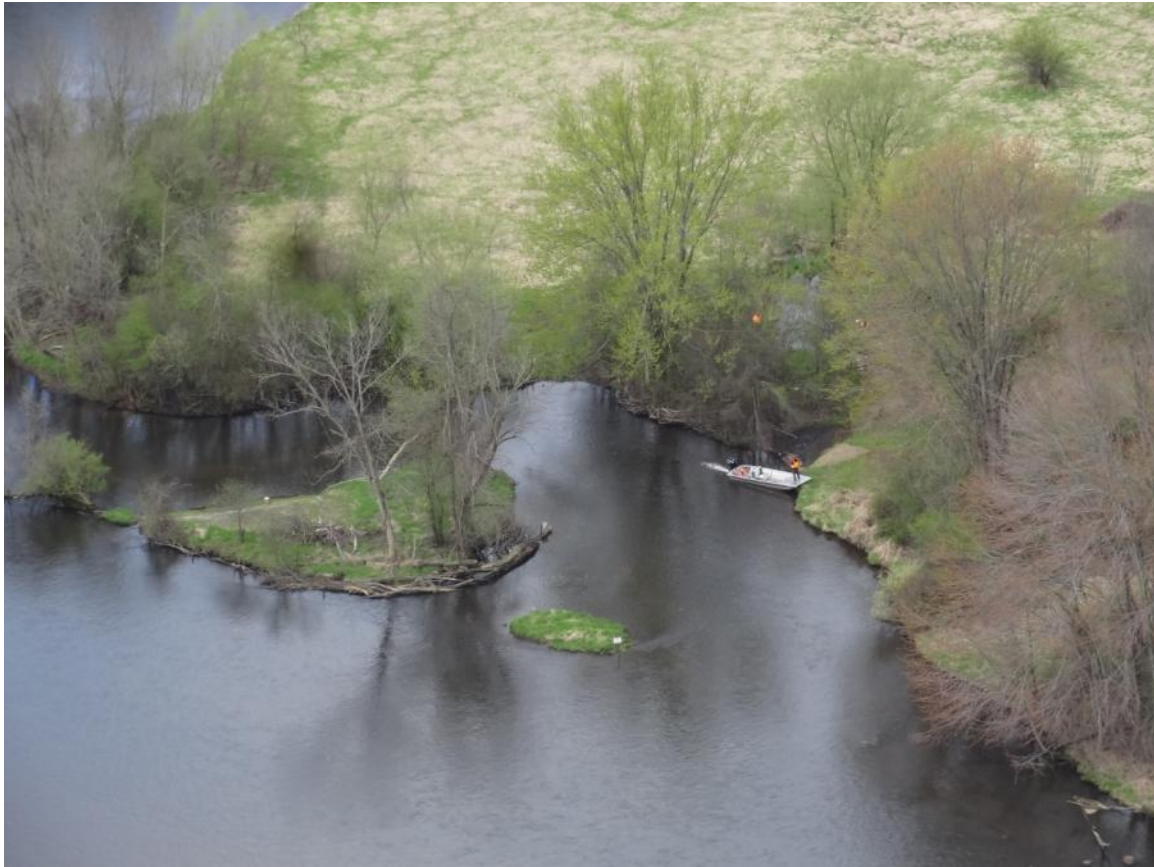
11. MP2.75 RDB observed crews assessing the area.

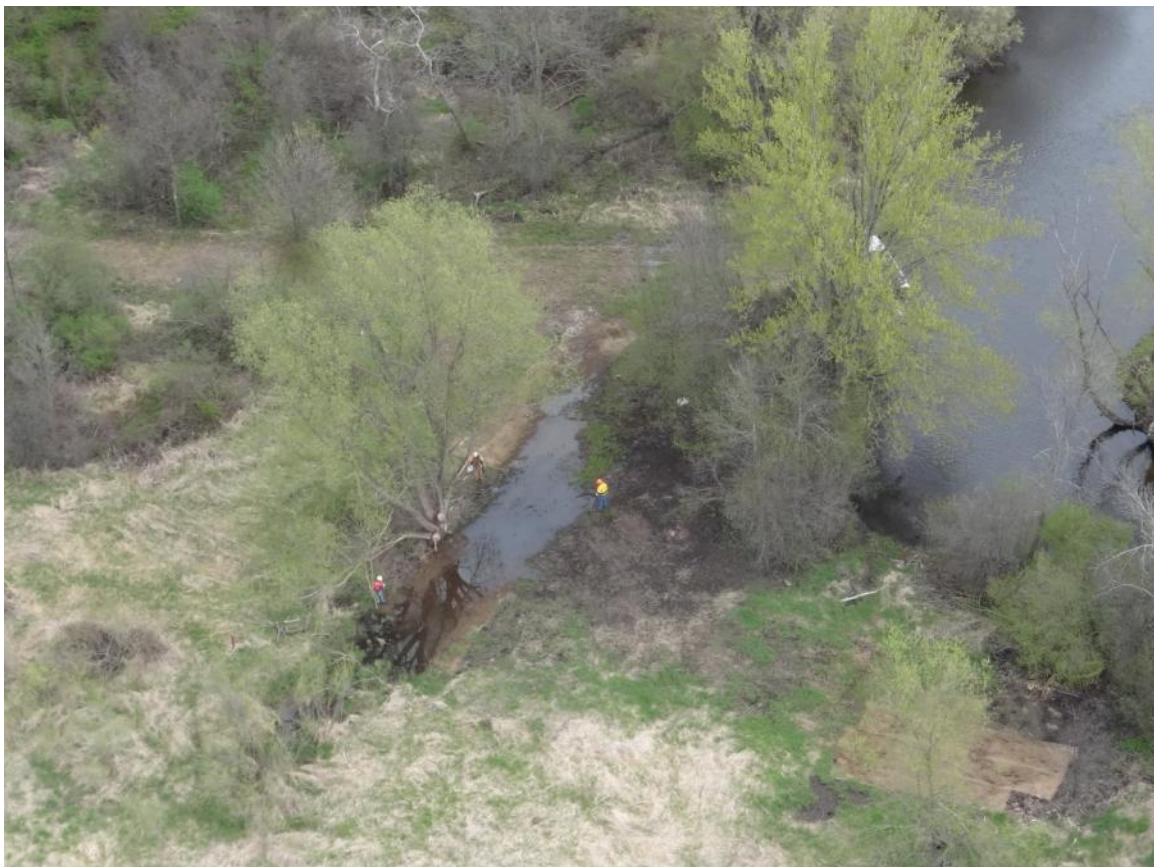
12. MP2.75 RDB observed crews assessing the area.

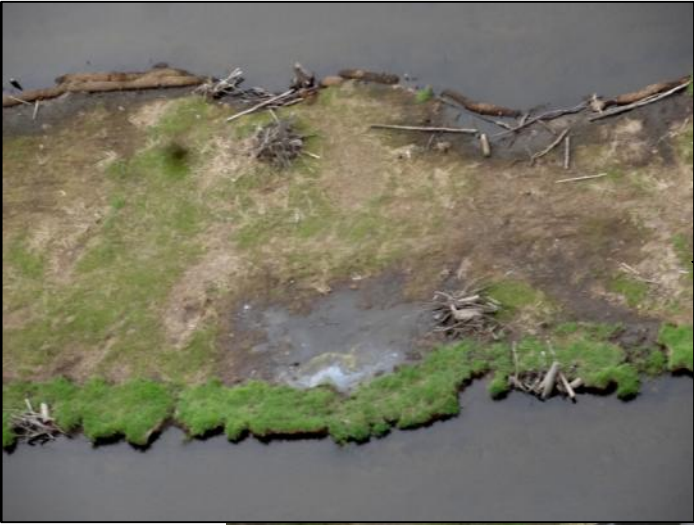
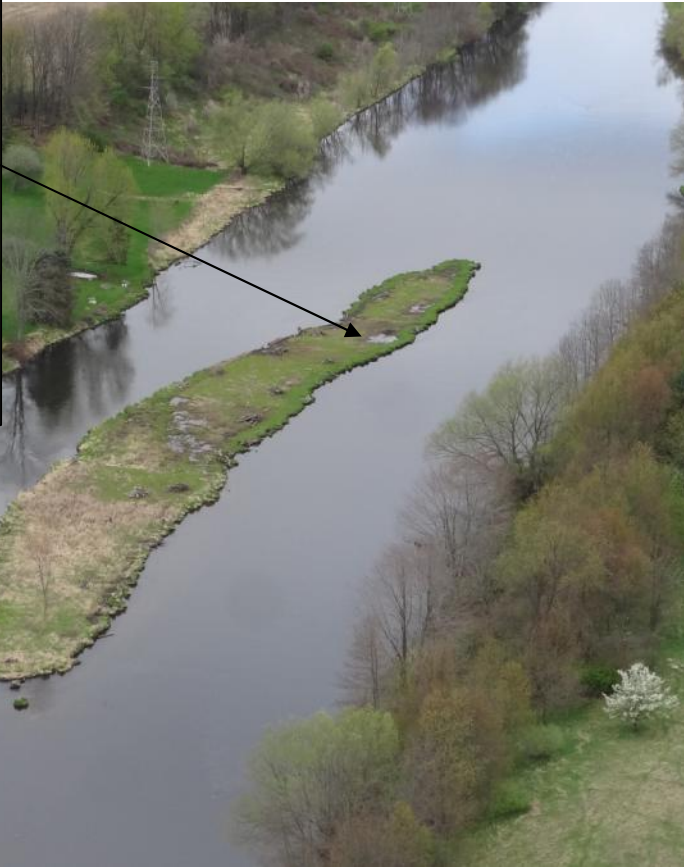
13. Island A sheen observed in pooled water.

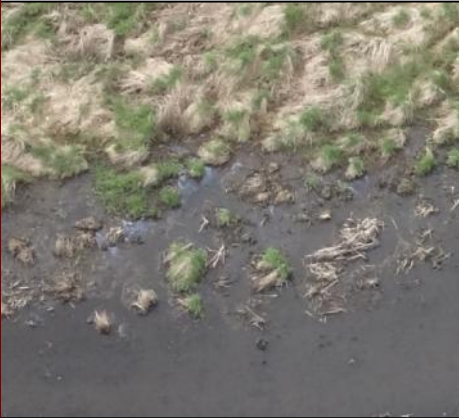
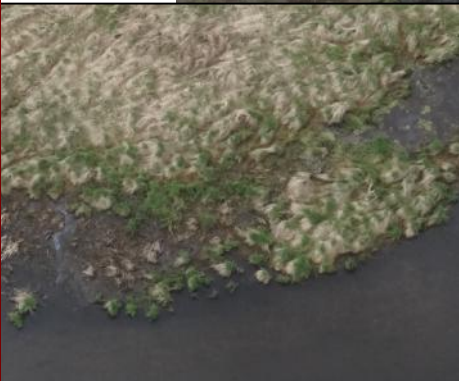
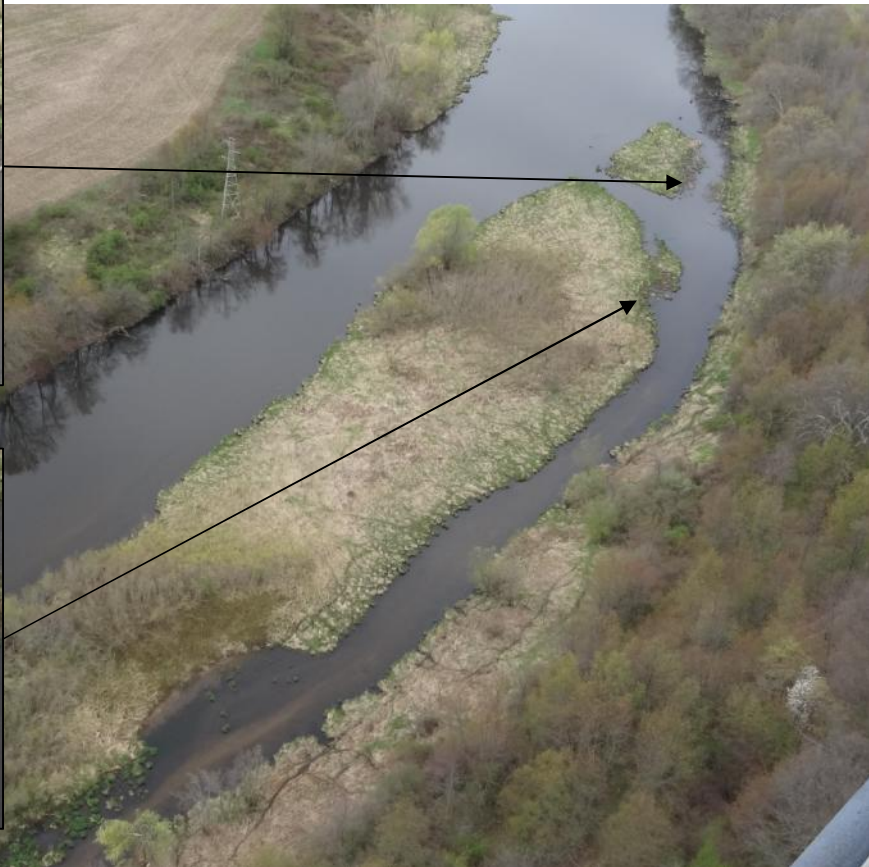
14. MP3.25 sheen observed.

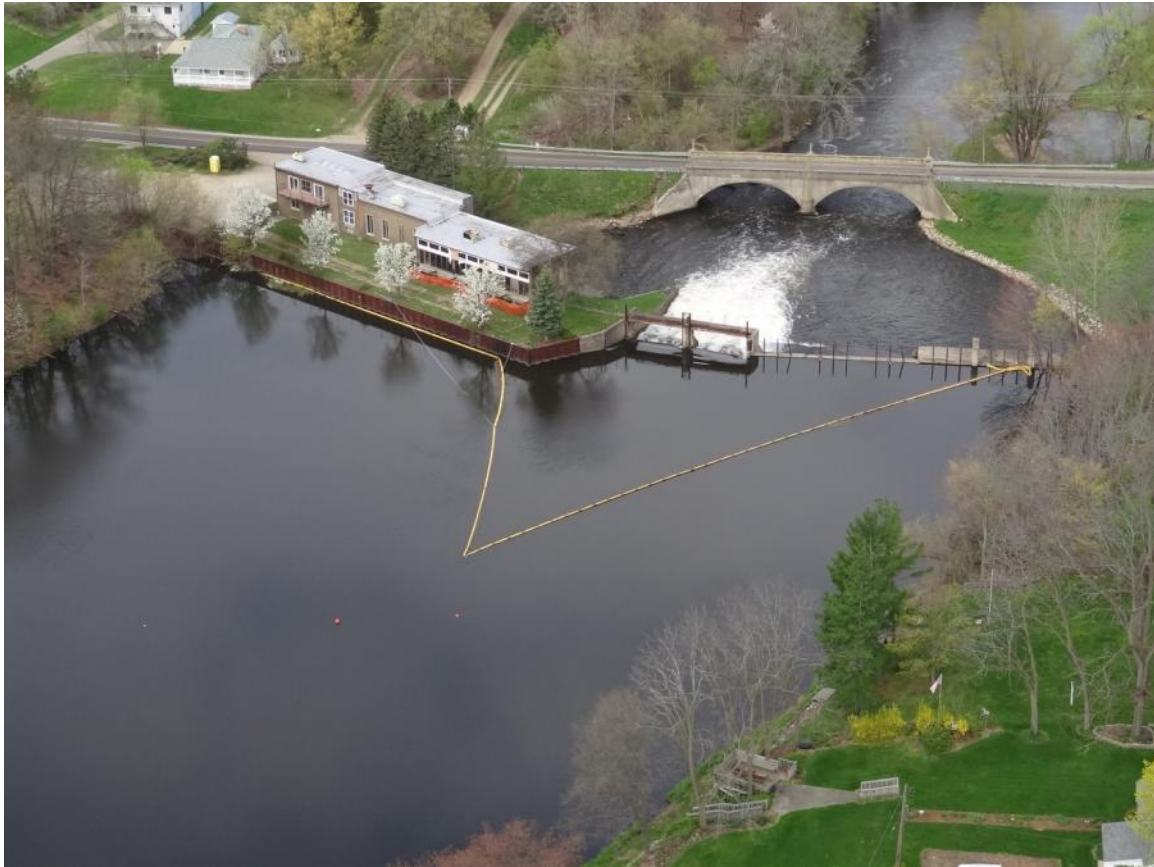
15. Ceresco Dam spots of sheen were observed RDB above the dam.

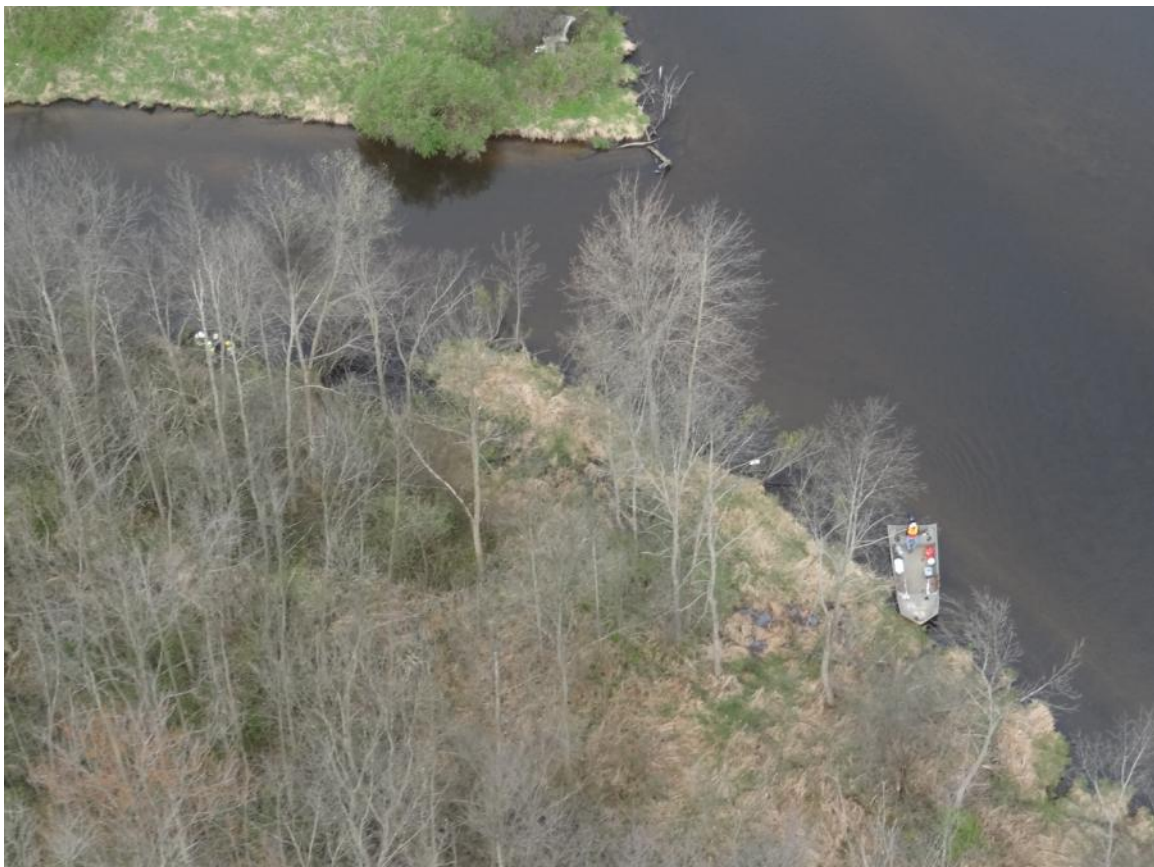
16. MP7.0 SORT crew observed.

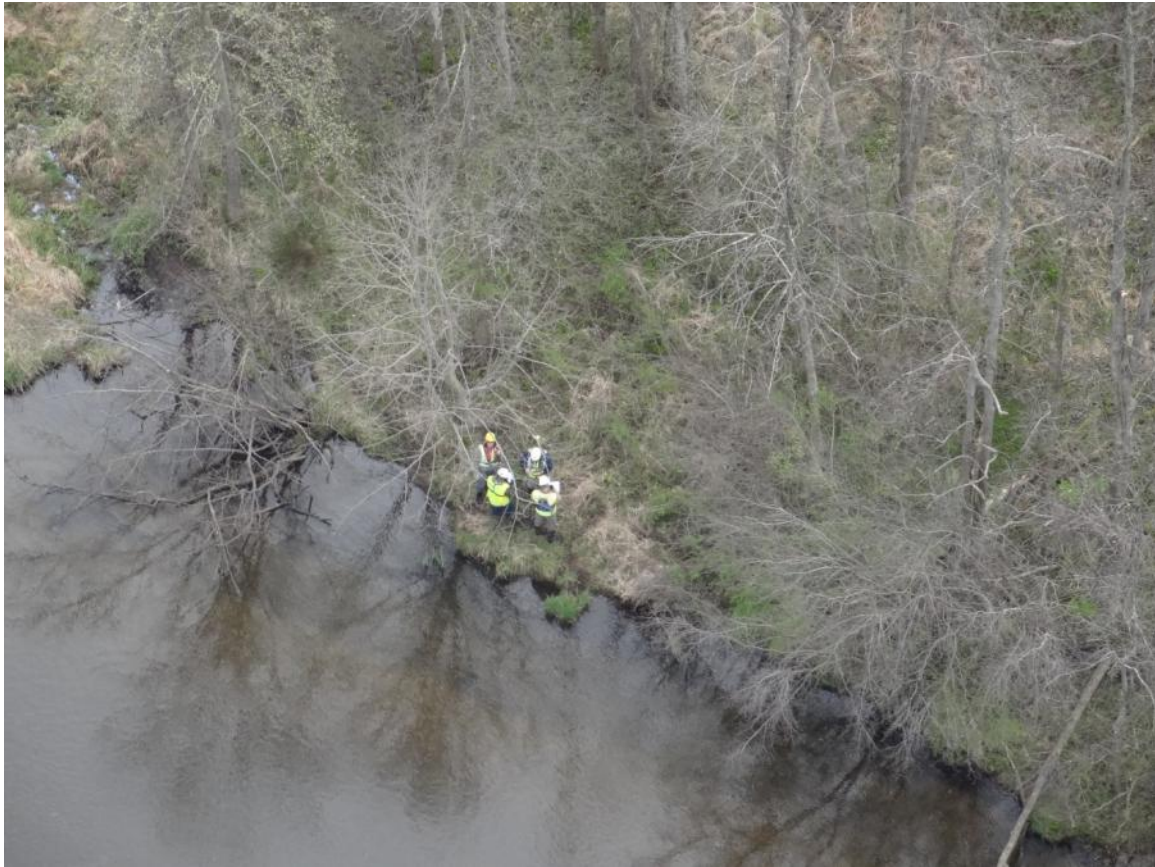
17. MP7.0 SORT crew observed.

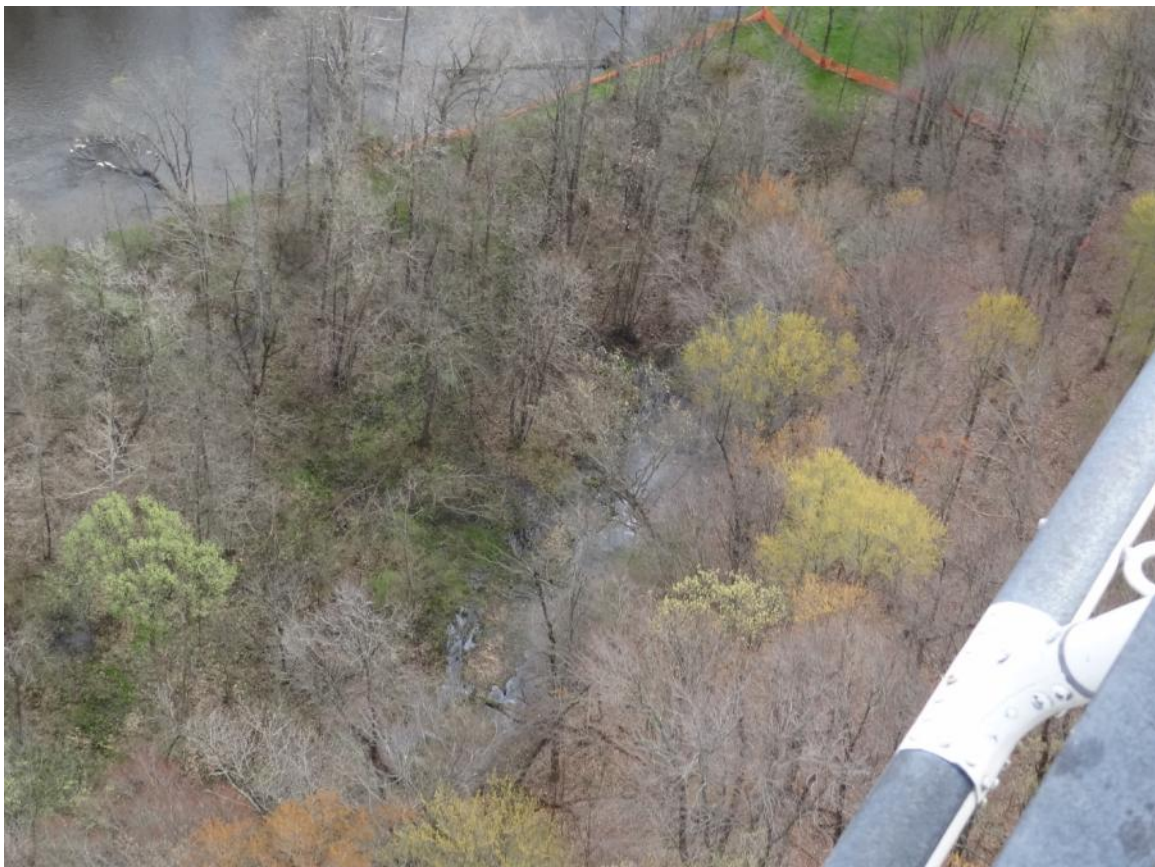
18. MP8.4 LDB sheen observed in back channel.

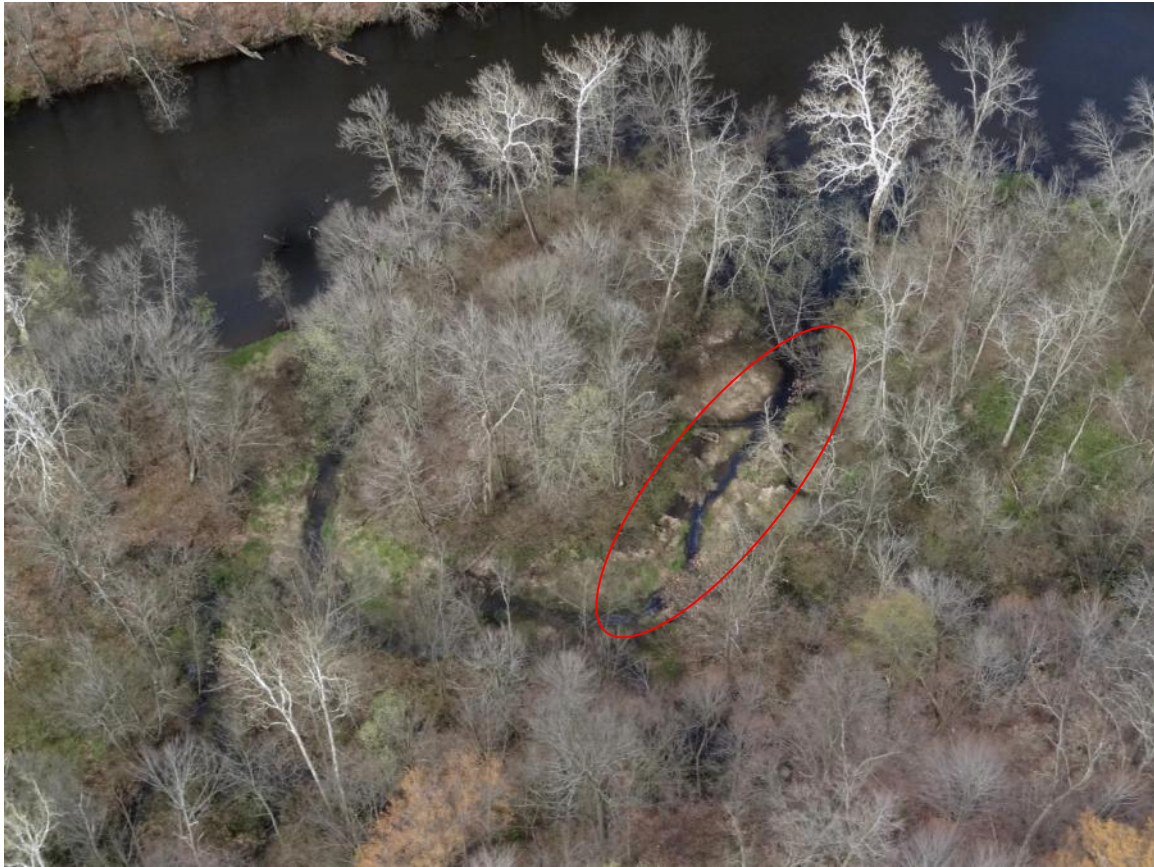
19. MP8.9 RDB sheen observed in side channel.

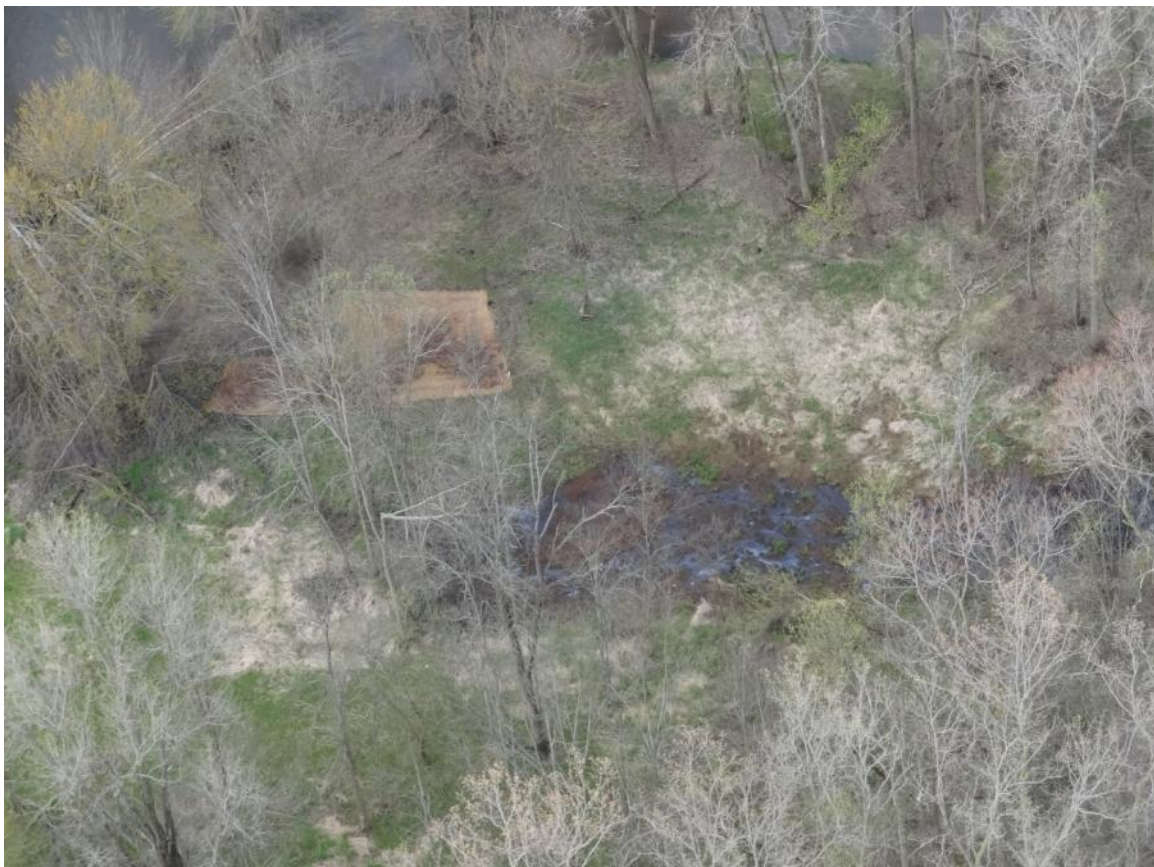
20. OB 10.37 sheen observed.

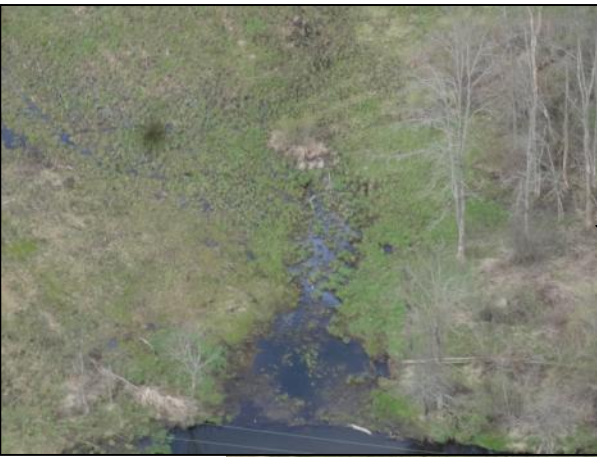
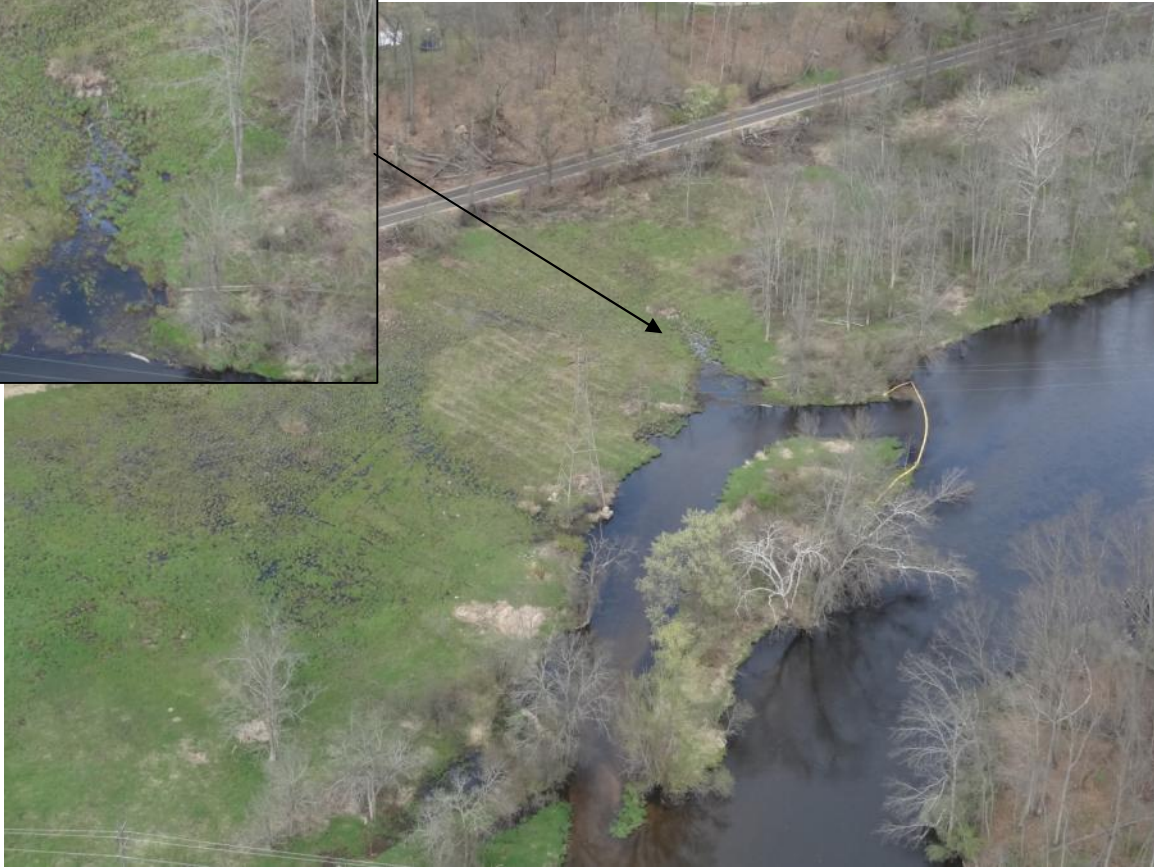
21. MP10.75 LDB sheen observed.

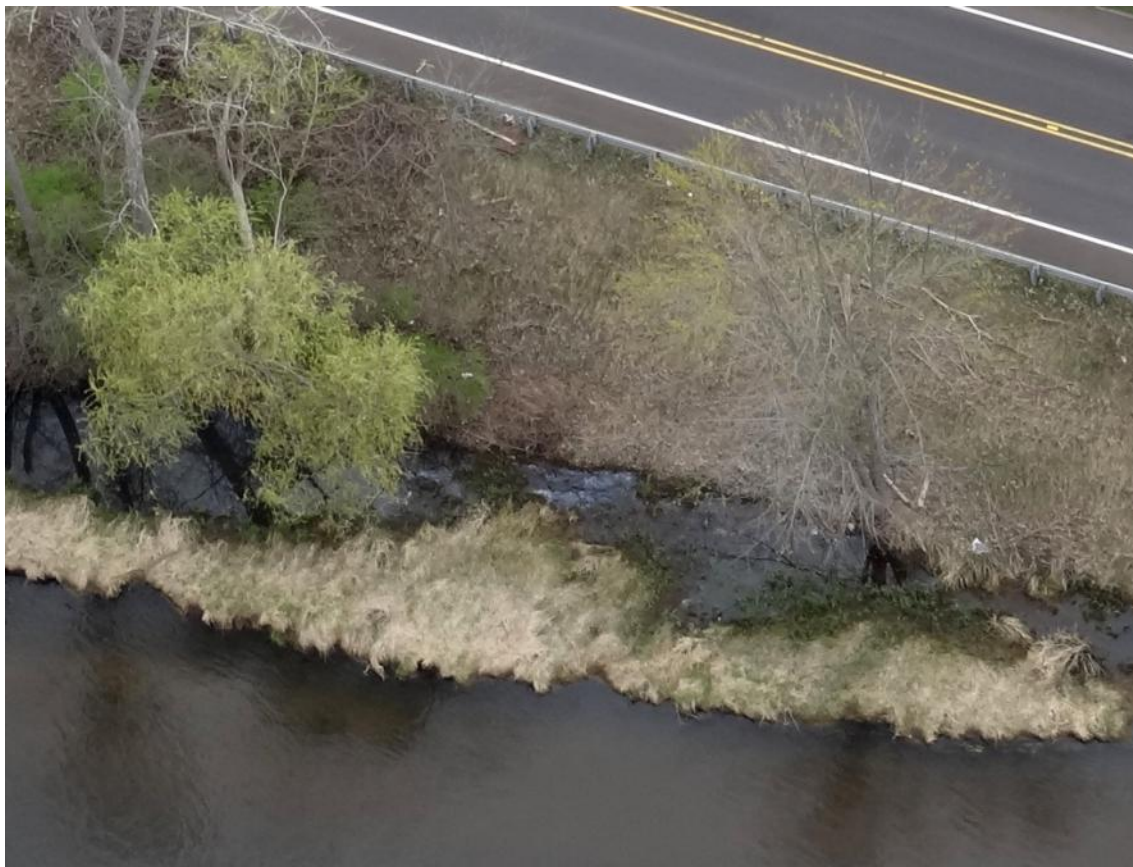
22. MP12.25 (South Raymond Rd.) LDB sheen observed.
